Maintenance Manual  
For  
Double Skinned  
Experimental Hang Balloon

VH-SIK – Mylar Magic

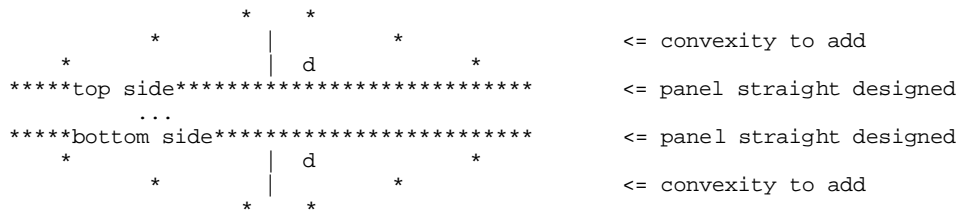
\*\*\*\*\* Data about the curved sides of the panels

The panels could be trapezoids, but to better the look of the balloon I advice to add a small curve to avoid a 'straight' effect on the panels. For this purpose, you have to curve the top and bottom sides of the panels by adding some millimetres of fabric at the centre of the top and bottom sides. This 'adjustment' will be more important if you want few gores and use large fabric rolls.

The 'd' value is the same for the 7 top panels. Its value is : 11.2 mm  
 The value is added two times to the panels : once at the bottom, once at the top but just added once for the top panel (only added a the bottom of this panel)
