Maintenance Manual  
For  
Double Skinned  
Experimental Hang Balloon

VH-SIK – Mylar Magic

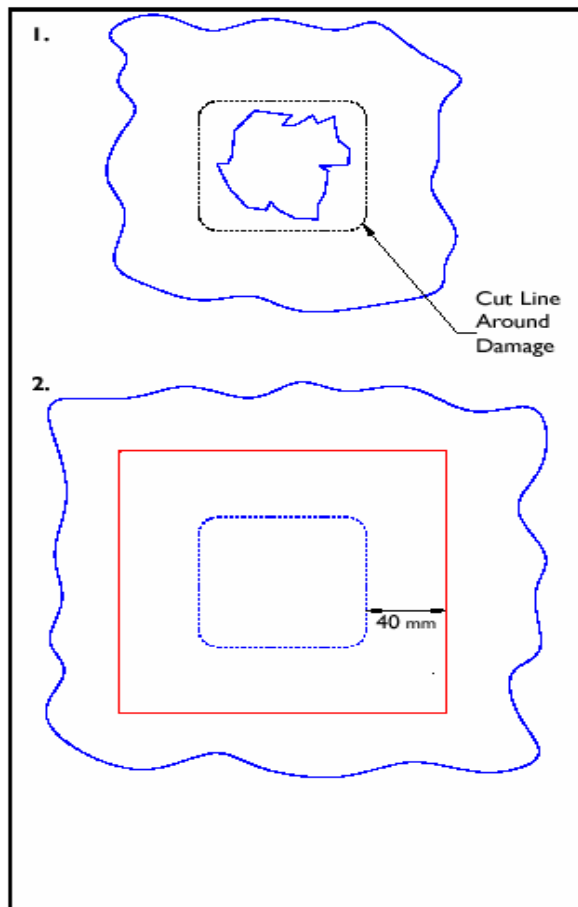
- ? Place a flat piece of wood inside the envelope, under the damaged panel. Remove the damaged area with a hot knife. Cut a rectangular aperture with radiused corners.
- ? Cut an oversized patch of 23µM film, adding 40mm seam allowance in each direction.
- ? Cut and attach 4 pieces of 25 millimeter 3M brand 9485 double sided tape around the hole to be patched leaving 5-8 mm clearance from the inner edge of the hole and completely surrounding the hole. Overlay the patch film to the panel and roll down using a rubber wheeled roller..

▲ 'Hot Cut And Overlay' Procedure

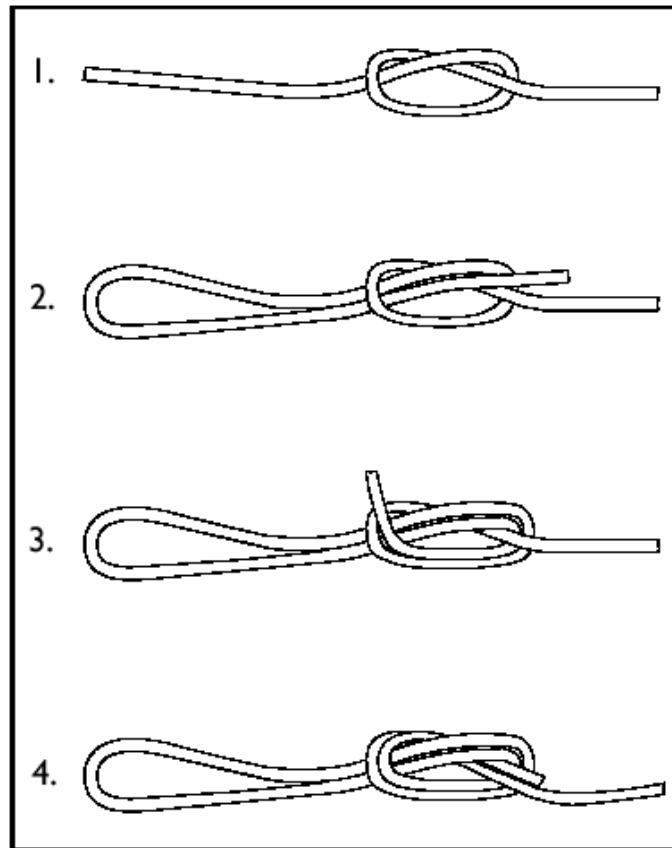
End loops in the cables must be made using the Cameron Knot.

▲ Tying The 'Cameron' Knot

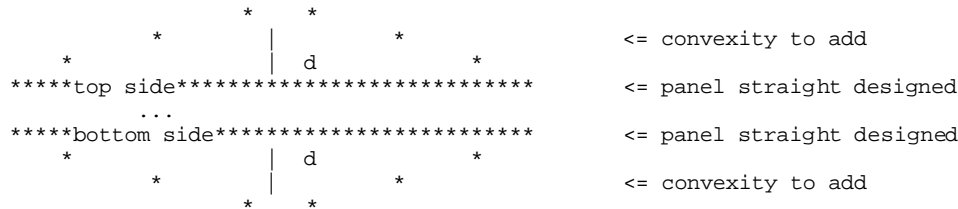
\*\*\*\*\* Data about the curved sides of the panels

The 'd' value is the same for the 7 top panels. Its value is : 11.1 mm  
 The value is added two times to the panels : once at the bottom, once at the top  
 but just added once for the top panel (only added at the bottom of this panel)

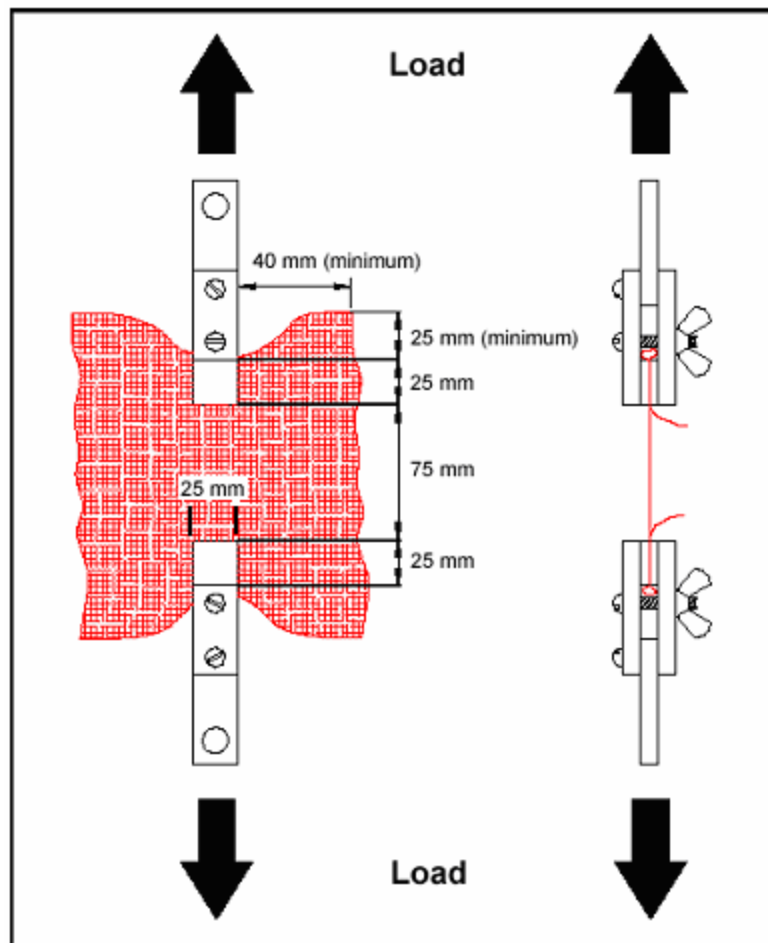
The fabric must be gripped with the jaw edges carefully aligned so that the same fibres are pulled from each end.

▲ Grab Test Procedure

The clamp edges must be parallel so that the fibres are loaded evenly. The clamp is to be tightened so that the fabric does not move in the jaws.
